December 1981

**THE STREAMBANK EROSION CONTROL
EVALUATION AND DEMONSTRATION ACT OF 1974
SECTION 32, PUBLIC LAW 93-251**

Appendix B - Hydraulic Research

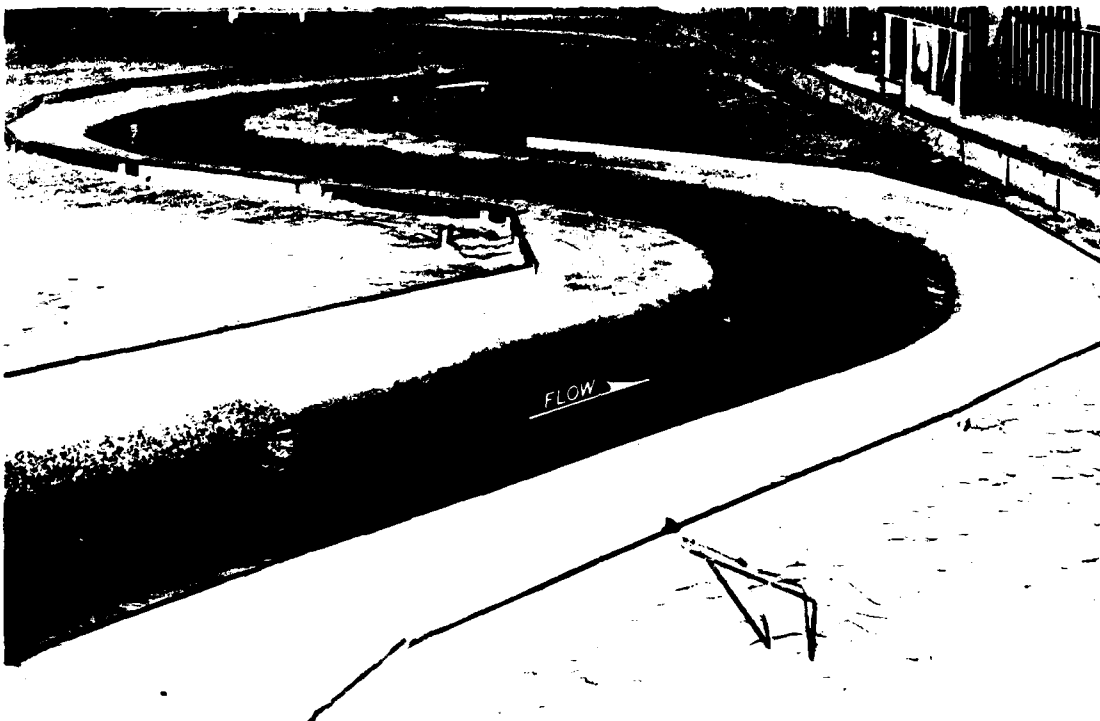
2. The model tests were conducted in a curved channel facility (Figure 1) having both sand bed and banks. Channel side slopes were initially molded to 1V on 2H and point bars were placed on the inside of the channel bends. No attempts were made to reproduce soil conditions in the model but sand was recirculated through the channel to simulate bed-load movement. A discharge hydrograph (Figure 2) was developed to represent long periods of low flow followed by a short duration bank-full discharge and each type of protection was exposed to four repetitions of the hydrograph.

Figure 1. Curved channel facility

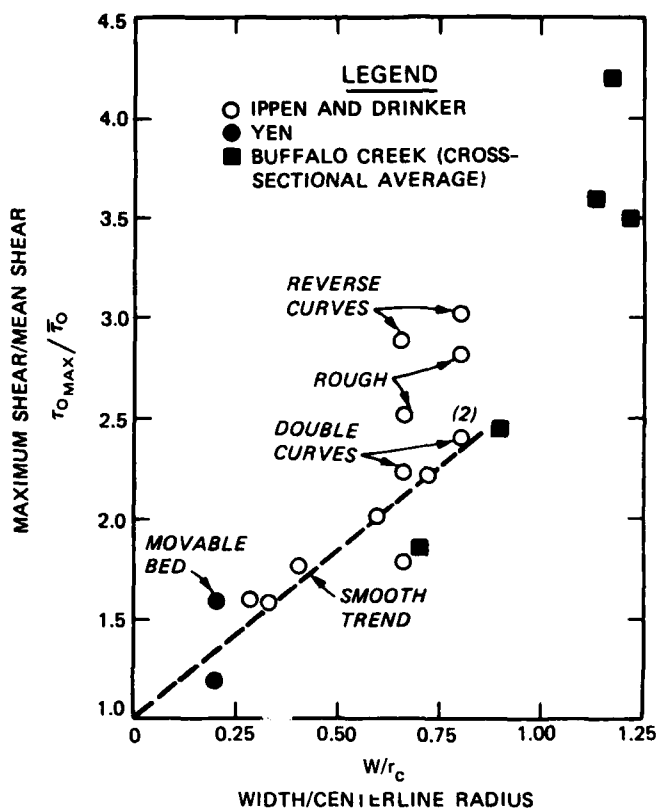
Figure 3. Relation of maximum shear to curvature ratio (Apmann 1972)

- a. The maximum shear increases with curvature ratio.
- b. Surface roughness increases maximum shear by about 15 percent.
- c. Upstream conditions play a significant role in amplifying maximum shear if in successive curves there is a reversal of direction; this increase was on the order of 30 percent.
- d. Combining these influences indicates that in a bend, maximum shears might be 50 percent above the smooth trend line drawn in Figure 3.

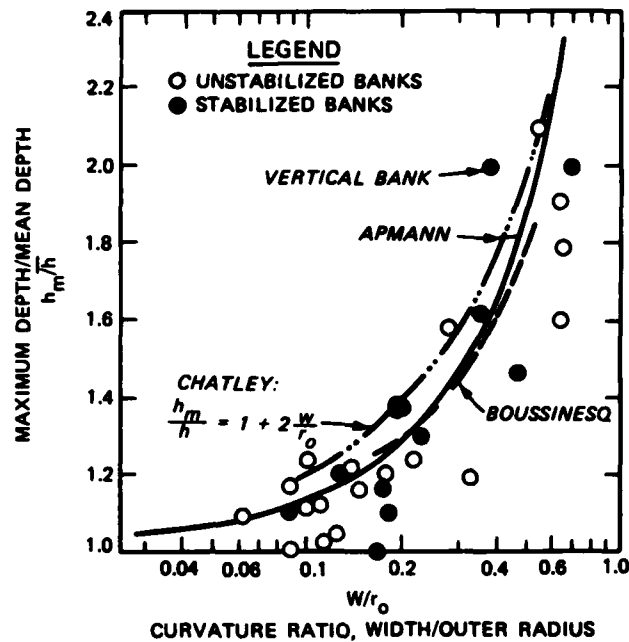
Figure 9. Relation of maximum depth to curvature ratio (Apmann 1972)

The coefficient n was found to be 2.5 for Buffalo Creek bends. Apmann suggests that the value n can be determined for a given stream for use in predicting maximum depths for flows larger than those for which data were collected. This maximum depth will then aid in the design of the depth of the toe of the bank protection required to prevent undermining.

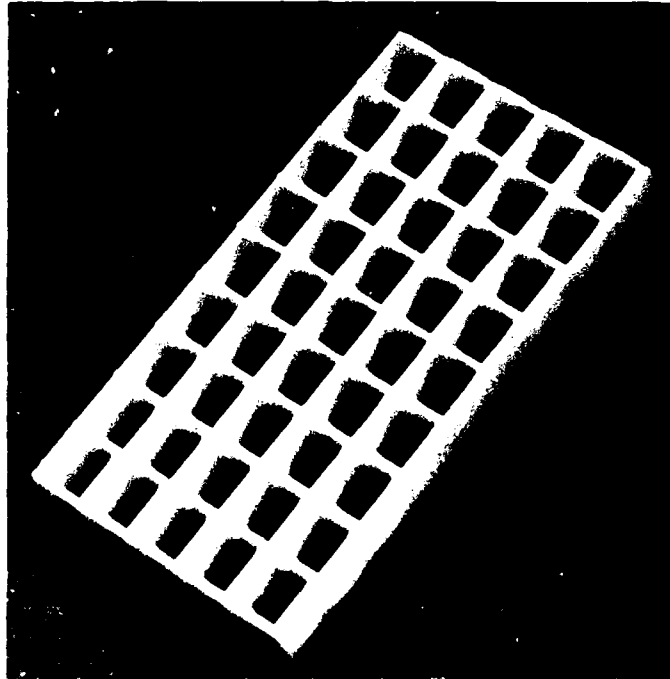
22. A plastic grid unit (Figure 10) was placed in the channel model to demonstrate and evaluate this concept. The grid was placed

Figure 10. Plastic model grid unit

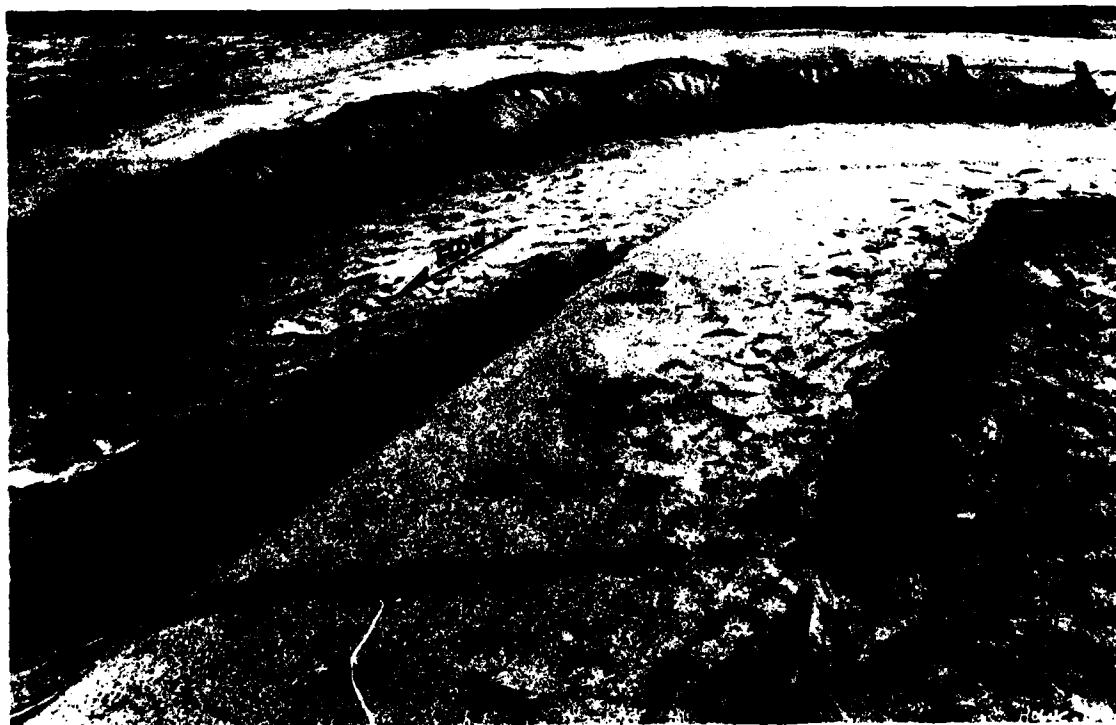
Figure 14. Riprap hard points

b. After flow

27. Limited model evaluation of hard points in a sharp channel bend was conducted to supplement field observations. A series of hard points were installed in the sand model in a 100-deg channel bend as shown in Figure 14a. The spacing of the hard points was two times the depth of flow at the maximum discharge at the upstream end of the bend and three times the depth of flow at the downstream end of the bend. The four hydrographs were run through the model and the after-flow condition is shown in Figure 14b. The bank experienced minor erosion between the closely spaced hard points at the upper end of the bend. More severe erosion occurred between the hard point at the downstream end of the bend which was caused by the greater hard-point spacing and possibly more severe attack at the downstream portion of the bend. Considering the relatively large amount of rock required for each hard point, a riprap revetment would probably require less rock than hard points for protecting sharp channel bends.

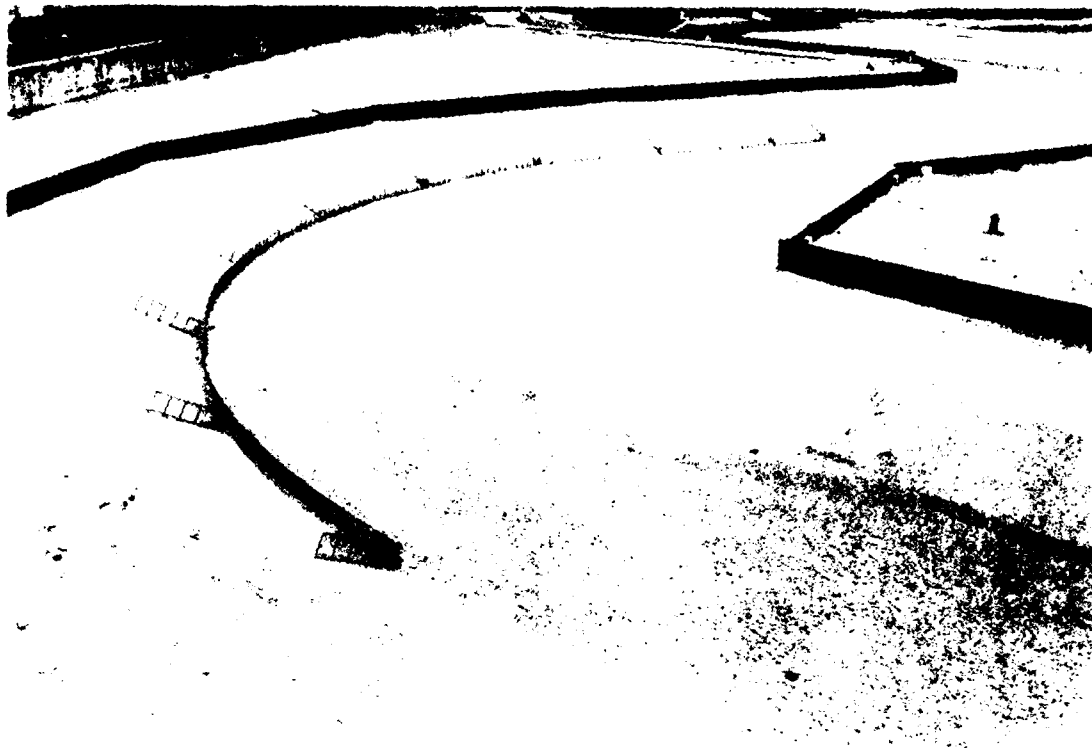
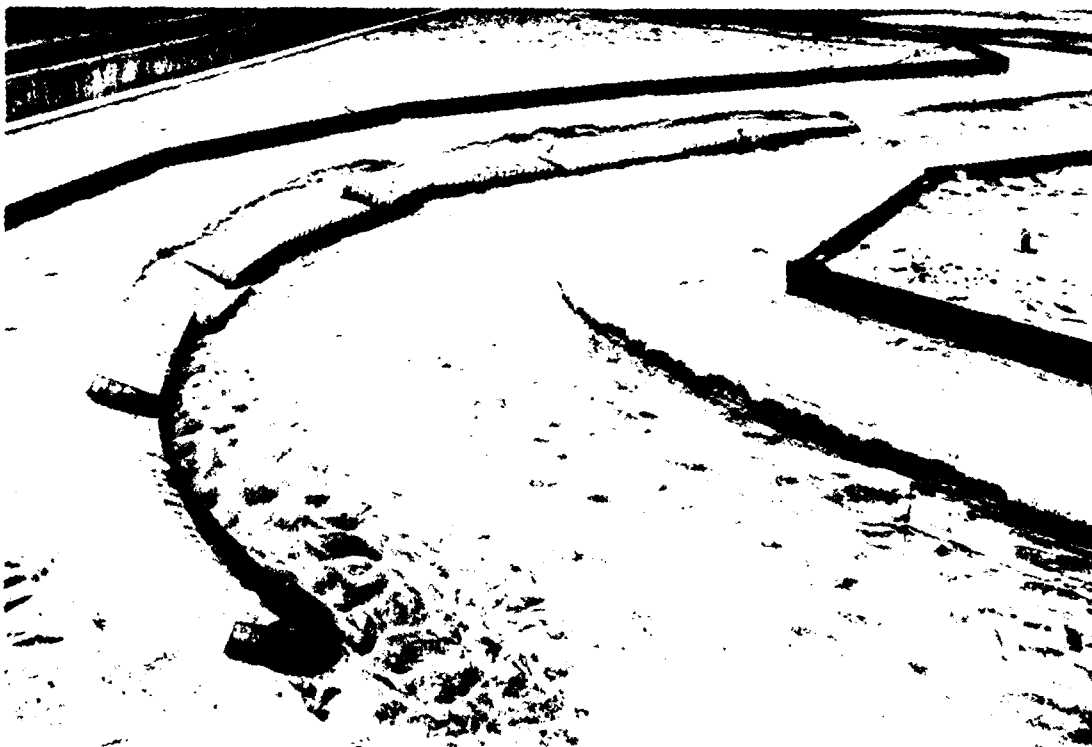
Figure 15. Single-row wire fence retard

a. Before flow

b. After flow

29. Several fencing schemes were evaluated in the sand model. A single-row wire fence retard with tiebacks is shown in Figure 15a. The tiebacks are used to prevent flanking and promote deposition behind the fences. The four hydrograph cycles were run through the model and the after-flow condition is shown in Figure 15b. Substantial toe scour took place at the base of the fence. This scour and the deposition and sloughing behind the fence resulted in failure of several sections of the fence.

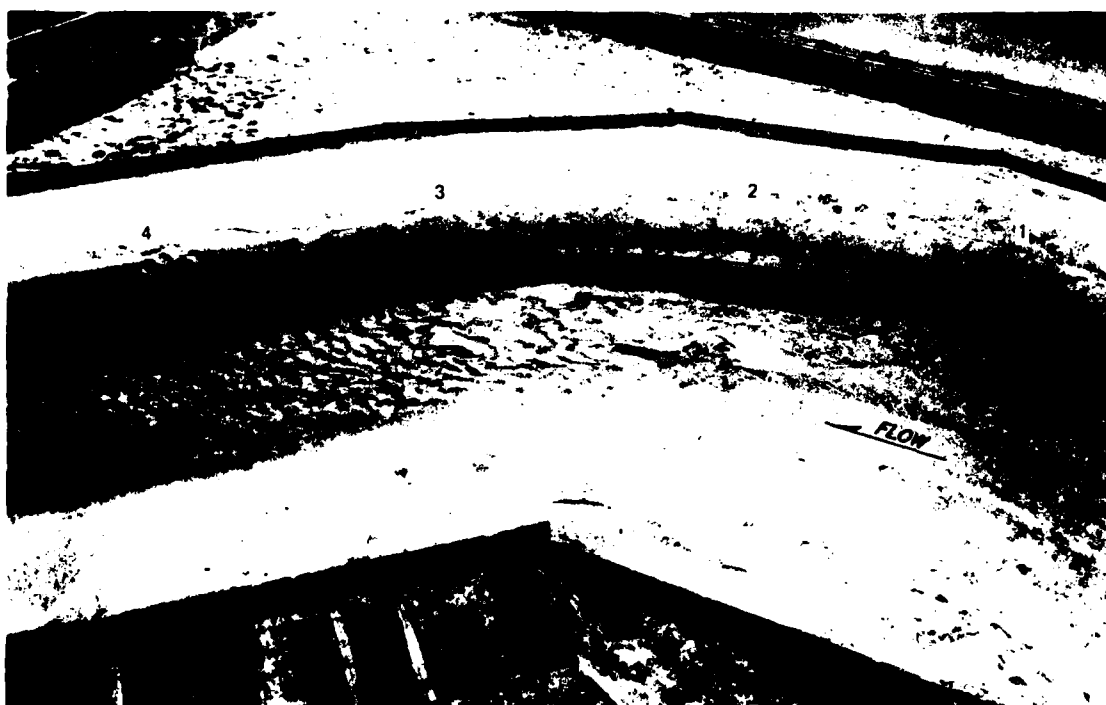
Figure 16. Double-row wire fence retard, anchored debris

b. After flow

in Figure 16a and consists of four different types. The first (upstream) section consists of a double-row wire fence without toe protection. The second section consists of a double-row wire fence with riprap placed on the channel side of the fence to provide toe protection. The third section consists of a double-row wire fence with riprap placed inside the fencing to provide toe protection. The fourth section consists of trees and debris anchored to posts at the toe of the slope. The hydrograph was run through the model four times and after-flow conditions are shown in Figure 16b. The unprotected fencing experienced degradation at the lower end of section 1 which would have ultimately failed the fence. Section 2 was in the area of most severe attack and considerable degradation occurred at the toe of the fence but the riprap launched and protected the toe from undermining. The third section suffered minor attack at the toe and rock launched to protect the toe from undermining. The fourth section remained stable but did not experience as severe attack as sections 2 and 3.

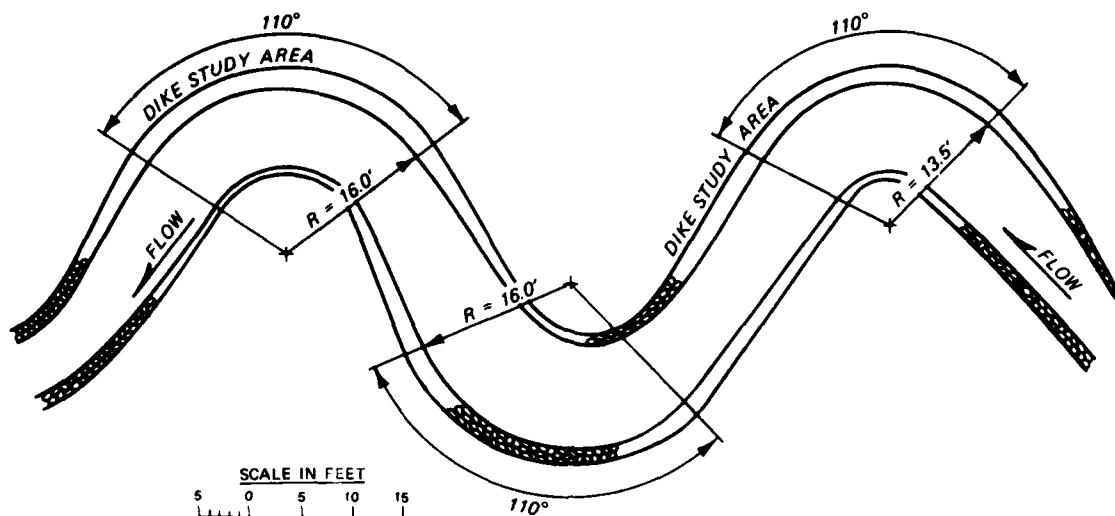
11. Model tests were conducted in a 130- by 50-ft sand bed flume. A meandering stream with three bends was molded in the flume as shown in Figure 3. The channel top width was 8 ft with an average depth of 0.24 ft. The stream sinuosity was 1.6 and the slope was 0.0012. A constant discharge of 2.7 cfs was recirculated through the model except for one test when a discharge of 4.6 cfs was used. There was bed-load movement in the model but no suspended load. The bed material was a

Figure 3. Streambank erosion test facility

medium sand and was recirculated. Velocities were measured at middepth with a paddle-wheel velocity meter. The spur dikes were made of sheet metal representing any relatively narrow impermeable structure. The stream was returned to approximately its original shape at the beginning of each test. Lines, 0.4 ft apart, were spray-painted along the bank for reference. A constant discharge was then run for 24 hr through the model. Most of the significant scour and bank erosion had occurred at the end of 8 hr, after which additional changes occurred slowly so that essentially equilibrium conditions had been achieved by the end of the test period. Effects of various spur dike spacings and orientation angles were then compared.

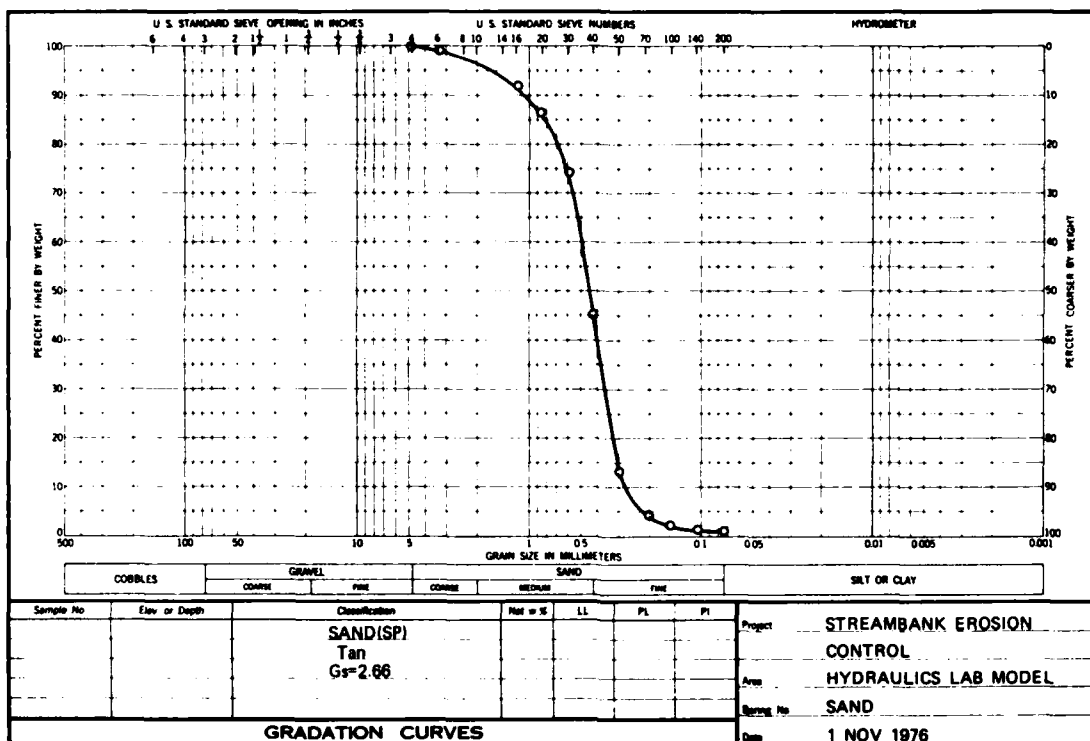
Figure 4. Gradation curve

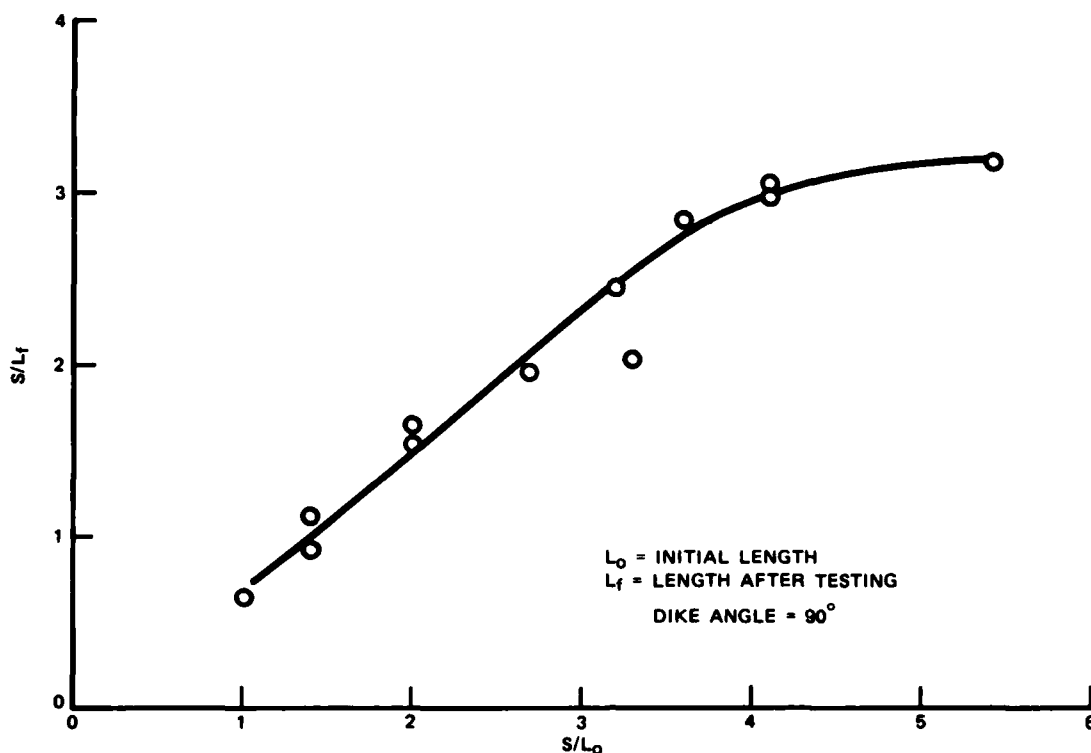
18. In the demonstration model the riverward ends of the spur dikes were initially set a specific distance from the bank. As the testing proceeded, bank erosion occurred between the spur dikes. The rate of erosion was rapid at the beginning of the test but was fairly stable after 24 hr. At the conclusion of testing the distance from the riverward end of the spur dike to the eroded bank was measured and used to determine a relatively stable spacing-length ratio. The initial and maximum final spacing-length ratios for each test are plotted in Figure 15. Data indicated that for the conditions in the demonstration model ($Q = 2.7$ cfs, $F_n = 0.4$), the optimum spacing to length ratio was about 3 to 1.

Figure 15. Spacing-length ratio; dike angle 90°

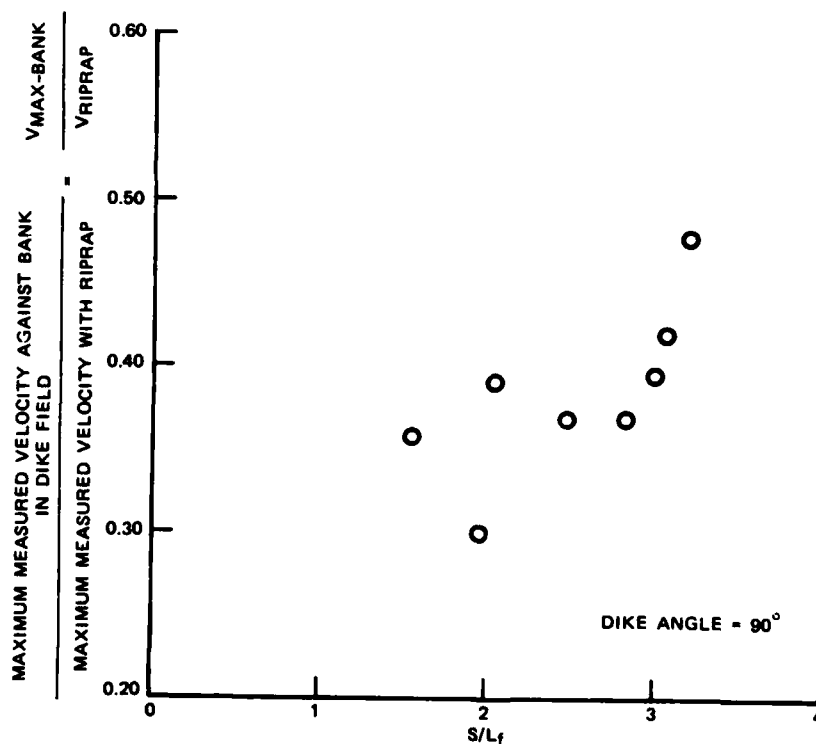
21. In the demonstration model, the maximum velocity against the bank in the spur dike field was approximately 40 percent of the maximum velocity measured against the bank in a similar concave bend protected by riprap. This percentage was slightly lower when the spacing-to-length ratio was near 1.5 and slightly higher when the ratio was 3.0. This relationship is shown in Figure 17. The reduction of depth and velocity against the bank between the spur dikes may make additional bank protection requirements minimal or unnecessary altogether, depending on conditions at specific sites.

Figure 17. Velocity reduction in dike field;
dike angle 90 deg

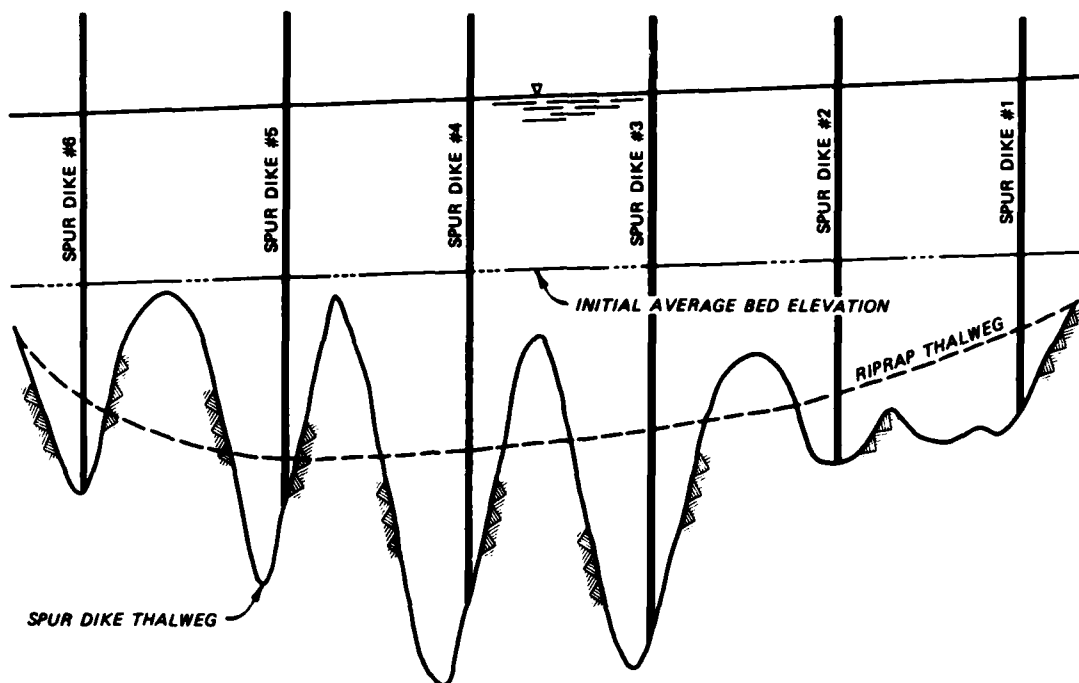
Figure 22. Comparison of thalwegs with riprap and spur dikes

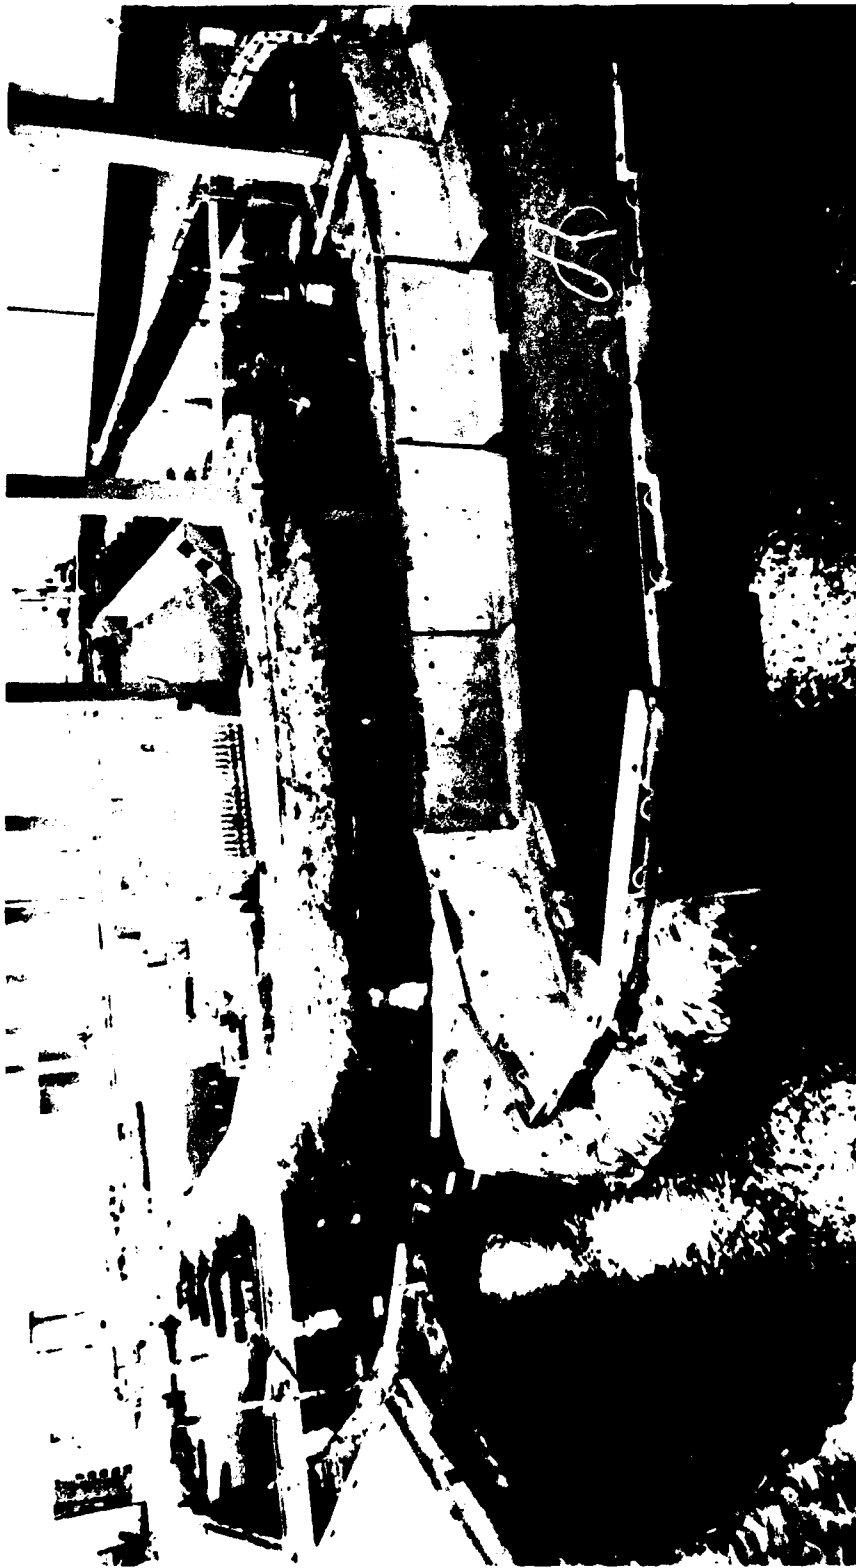
Photo 1. General view of the interior of the Mead Hydraulic Laboratory. The model shown in the photo is of the navigation channel at the junction of the Kansas and Missouri Rivers near Kansas City, Missouri. Model walls are formed from individual inverted T sections of pre-cast concrete. Bank and bed material of model is ground walnut shells. Bridge assembly for sonic sounder is shown in left center with X-Y plotter at right of bridge. Stilling well stand for water surface monitoring in center of photo. Water surface monitoring devices not visible through sediment laden water. Recirculation line in background with pump assembly at right.

4. The model facility is inclosed in a building 100 feet wide and 160 feet long. See Photo 1. Five miles or less of river can be modeled within these confines. Portable wall sections are used to form the interior boundaries of the particular river model under investigation. Lightweight ground walnut shells are used to simulate the stream bed and banks. Water and ground walnut shells are simultaneously recirculated through the model during testing thereby simulating both the water and sediment transport of a natural river system.

5. The portable wall sections forming the boundaries of the river model allow a large degree of flexibility in laying out various river shapes and alignments. These sections are inverted T-shaped lengths of pre-cast concrete, four feet long and two feet in height. The sections are equipped with necessary mountings to attach railings and auxiliary measuring equipment to the top or sides of the walls. See Photo 1. Once the general alignment of the prototype reach has been established, the sections are sealed to each other and to the floor with water proofing compound. At the completion of a study, they may be taken apart, and reused for the next model investigation. This method of construction permits rapid changes from one model

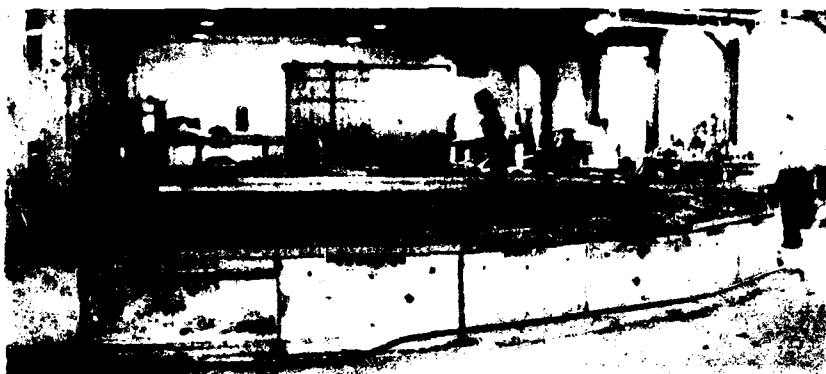
Photo 9. Reconstruction of sand bed model. Horizontal bar in mid-section of photo fixed at left to center point of curve. Right end of bar free to slide along outside edge of basin. Person at right sliding end of bar while person in channel removing excess material from in front of template attached to bar.

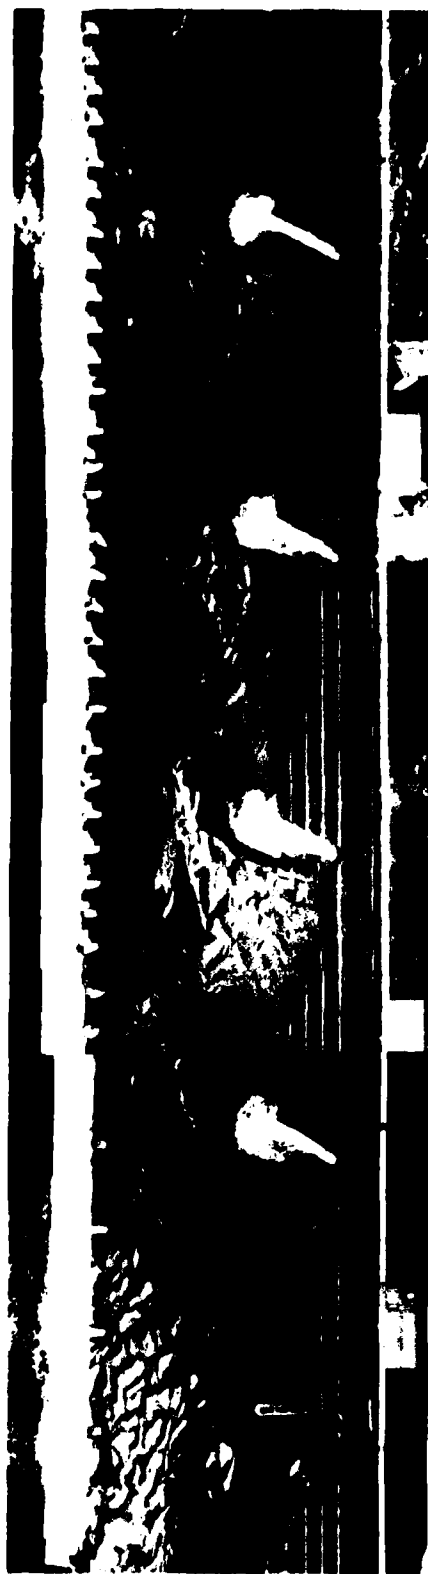
Photo 26. Development of erosion pattern with hard point root alignment at 30 degrees upstream from the perpendicular position. (Note the deterioration of the root.)

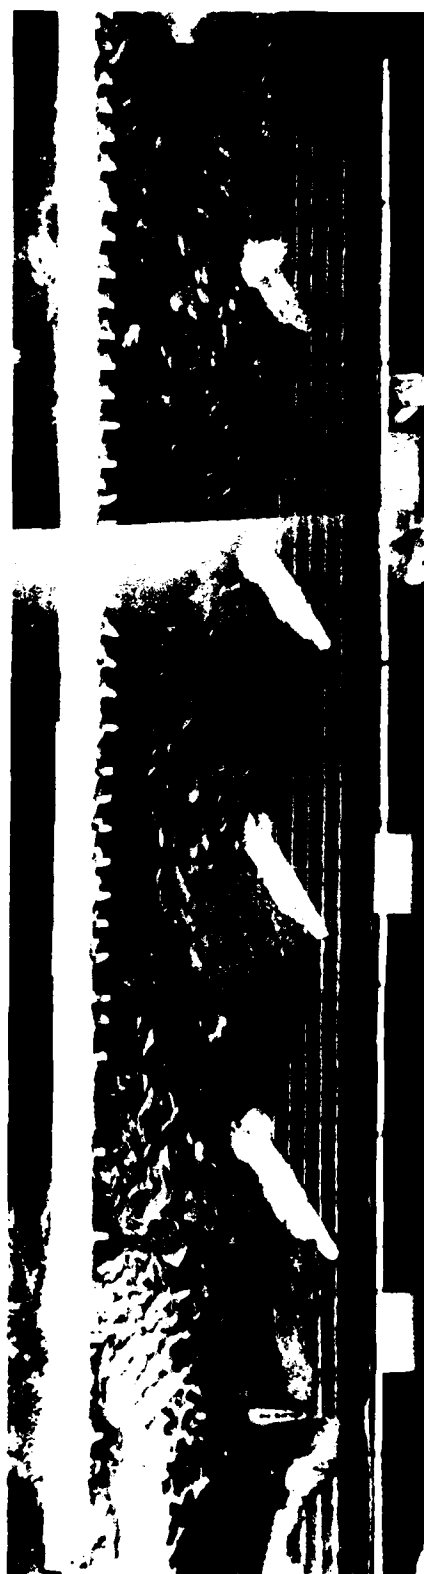
Photo 27. Development of erosion pattern with hard point root alignment at 60 degrees upstream from the perpendicular position. (Note the deterioration of the root.)

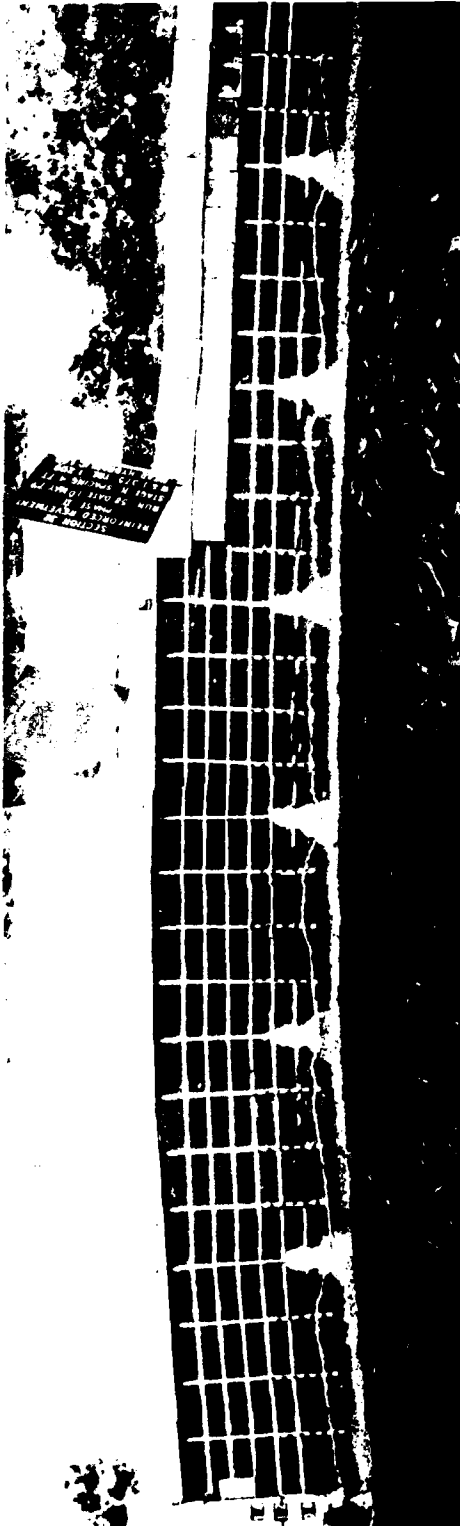
Photo 32. Overhead view of test area at the end of Run 58, Type I. Tieback spacings of 4 feet (160 feet prototype), toefill crown was at elevation 0.18 foot below NWS, and stage at NWS (unprotected depth of 0.18 foot).

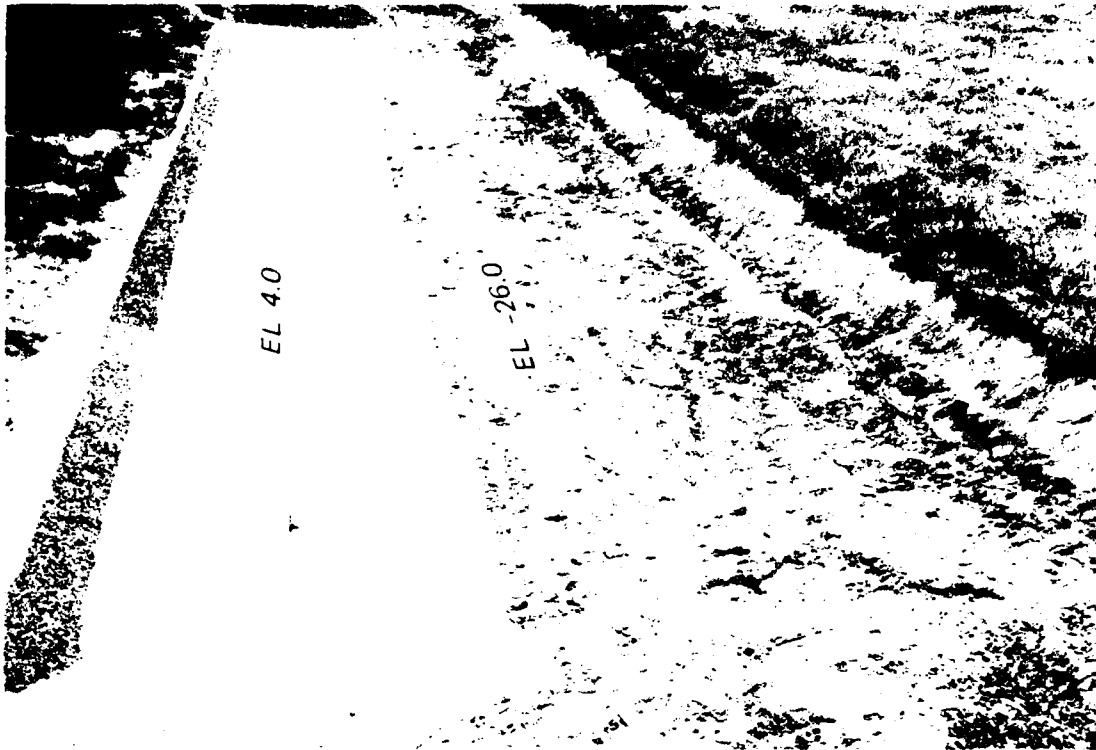
Figure 1. 1:30-scale model of 0.5-mile reach of SRDWSC

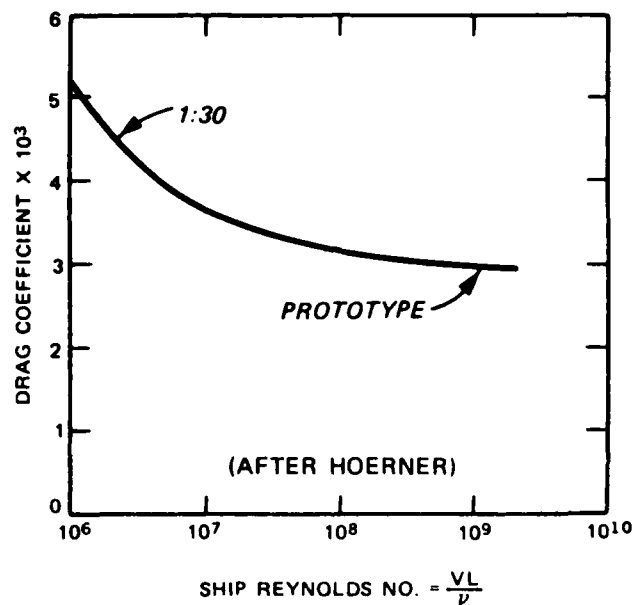
typical prototype and the point on the curve for the 1:30-scale model used in this investigation. Drag coefficients in the model are relatively close to those of the prototype, and only a small increase in thrust in the model was required. Water-level drawdown and return surge or a classical bore are the most likely failure mechanisms in the SRDWSC. Drawdown is a function of the cross-section ratio and the ship speed. The increase in thrust required in the model to simulate a given prototype speed should not affect the similarity of the drawdown phenomenon.

Figure 3. Drag coefficient as a function of ship Reynolds number (from Huval and Pickering 1978)

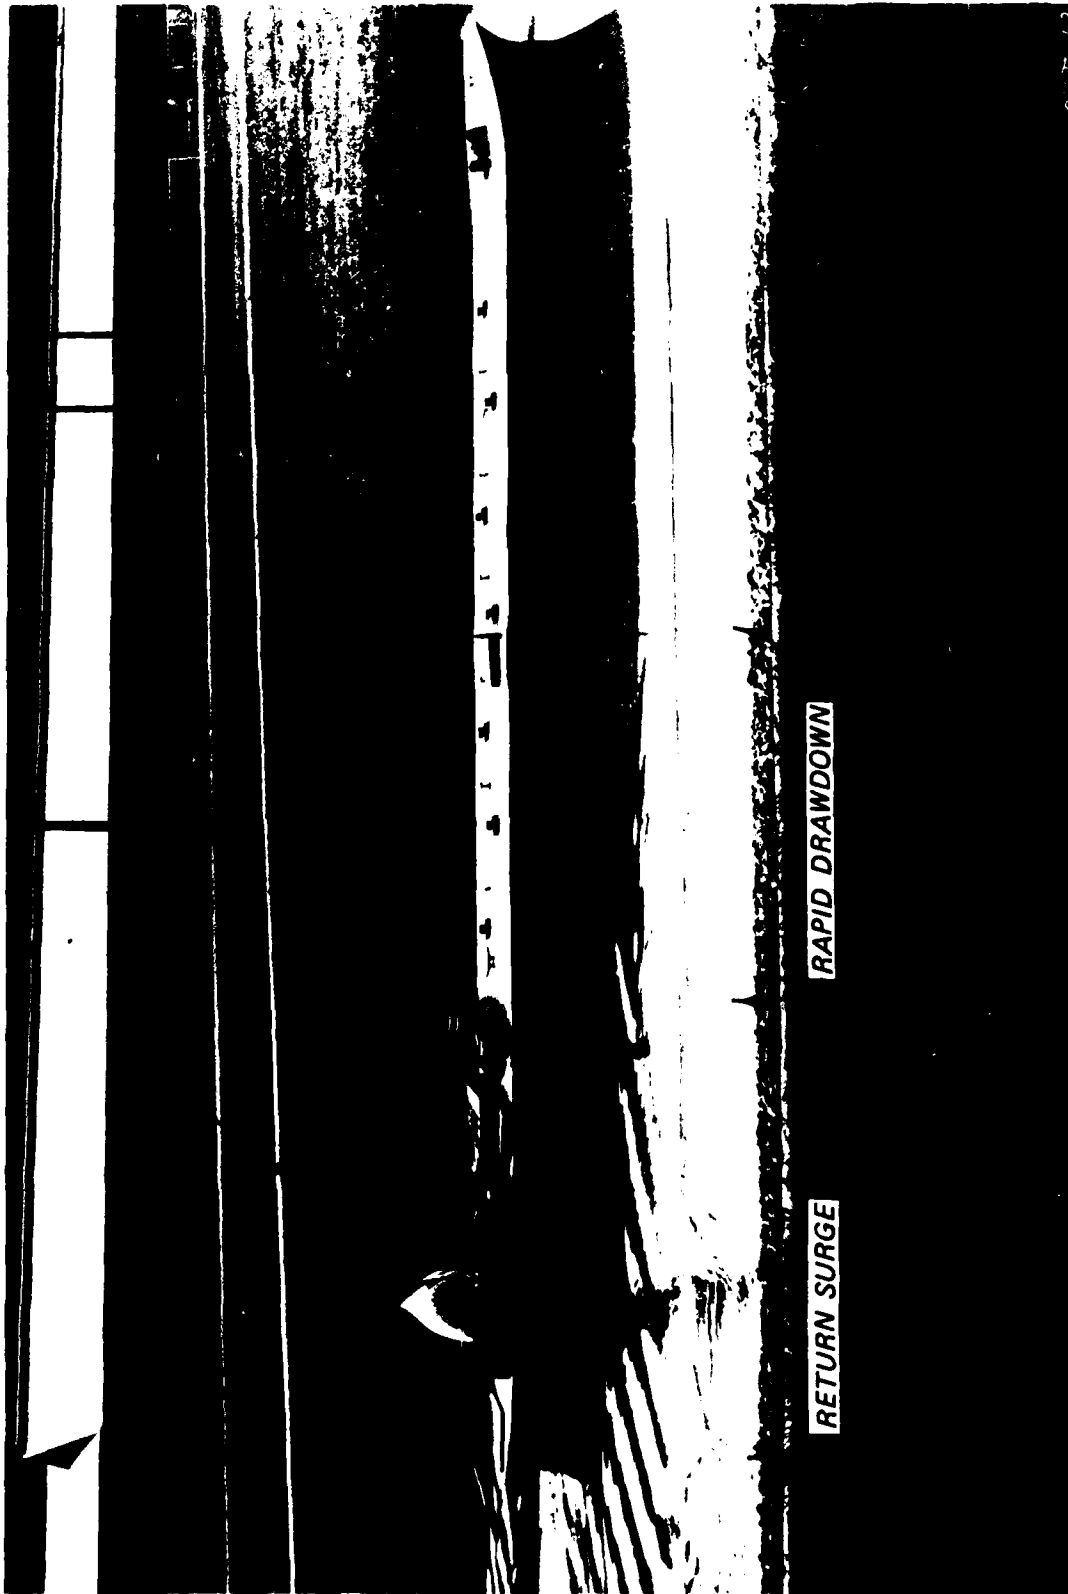
Figure 4. Rapid drawdown followed by return surge

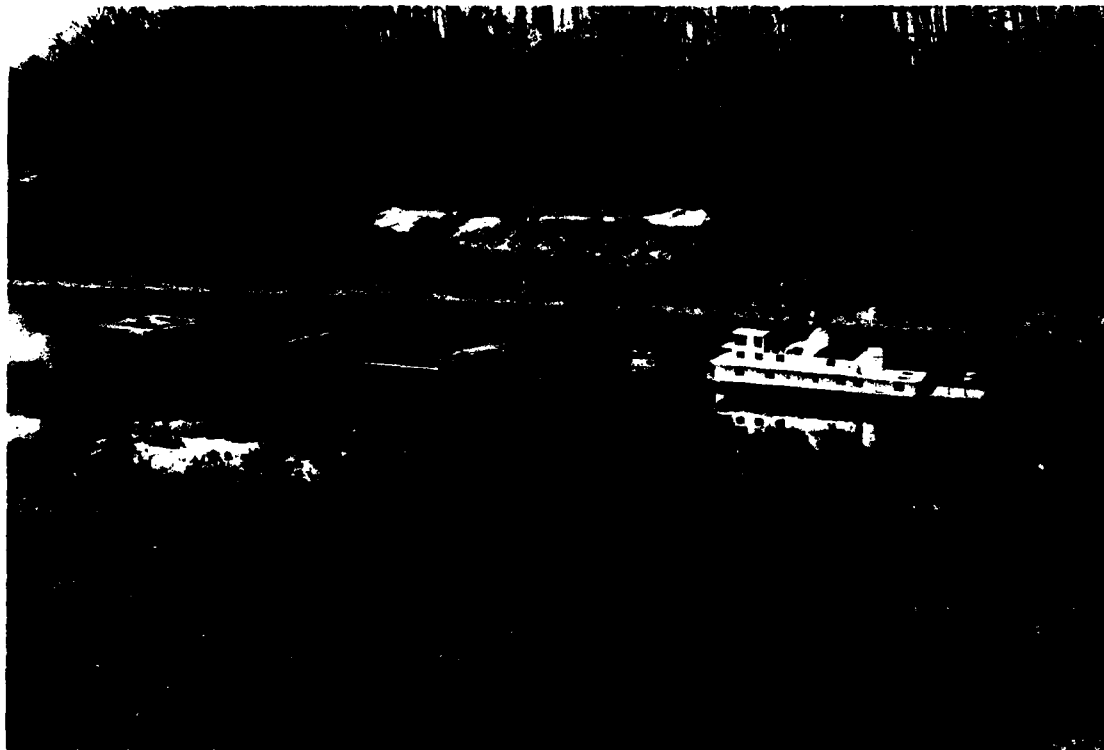
4. Each test was conducted with the vessel held in a stationary position over the riprap test section in the slack-water channel and the required propeller speed was established in the model. Depths were gradually lowered until failure of the bottom riprap was detected. Each riprap size was subjected to a 9-min duration of the full thrust of the towboat at each depth before the test section was inspected for failure. Depths were measured with staff gages and riprap failure was determined by observing either rock movement or exposure of the underlying filter fabric. Tests were conducted with both forward and backward thrust and attack of the rock was similar in the slack-water channel.

Figure 1. 1:20-scale model tow

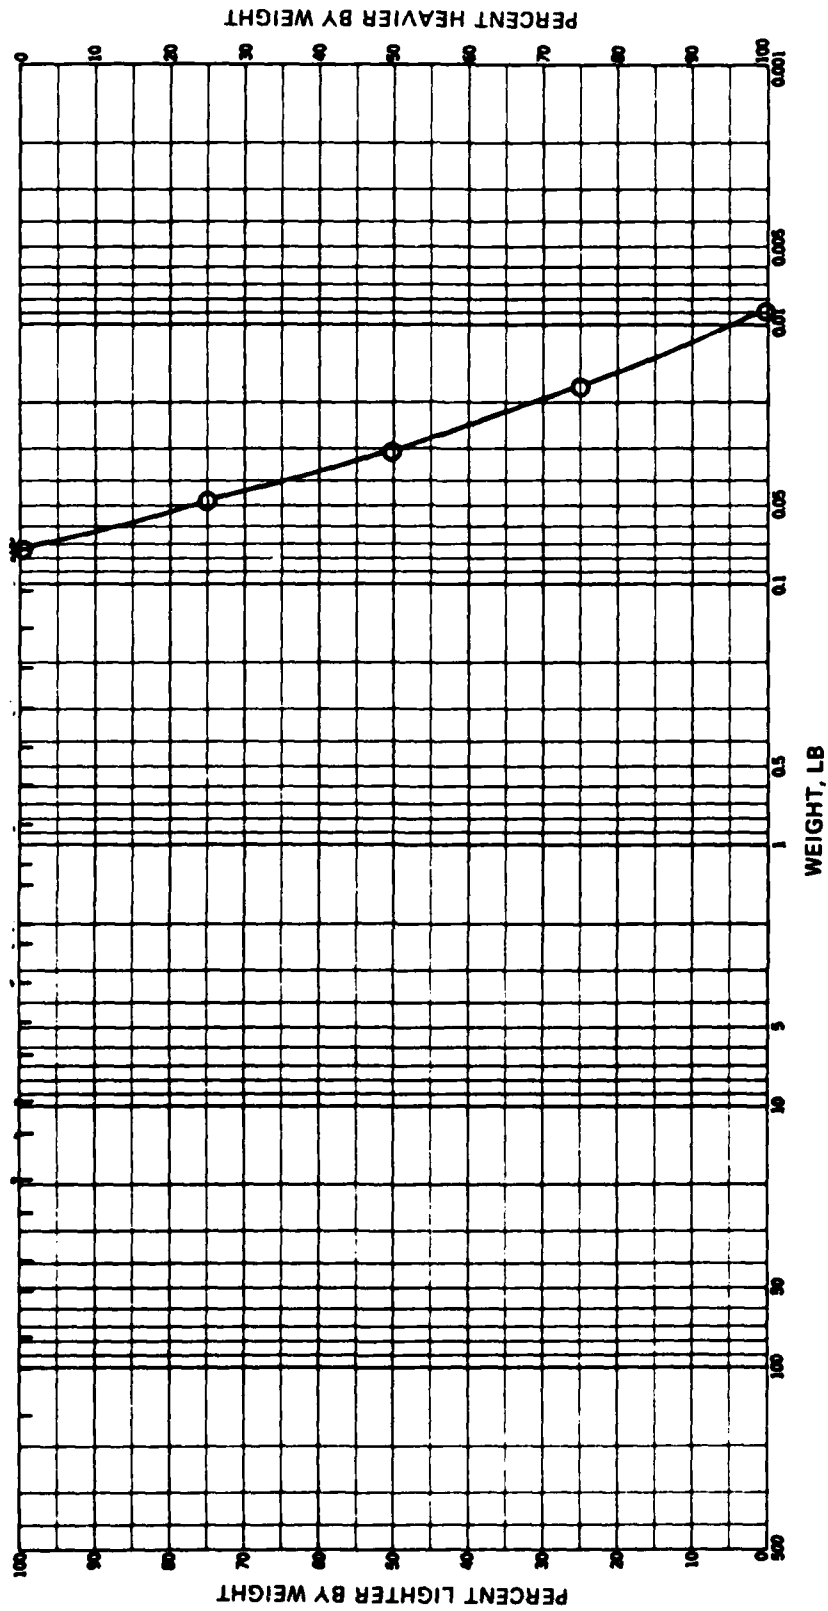
Figure 36. Weight gradation curve for gravel mix

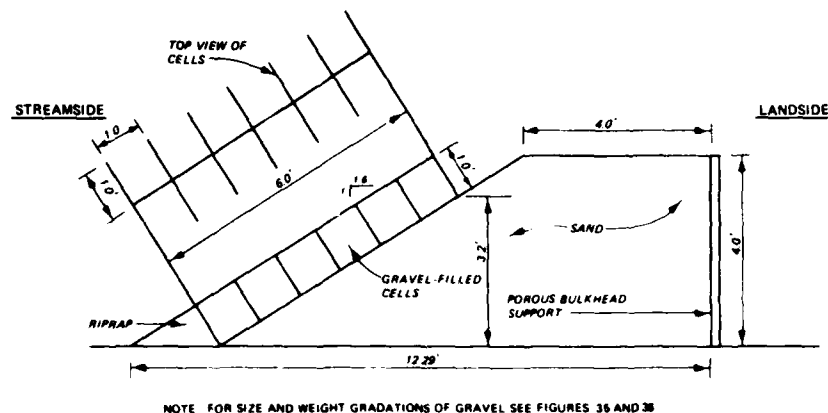
Figure 37. Plan 8A, sand streambank with gravel-filled cells protection

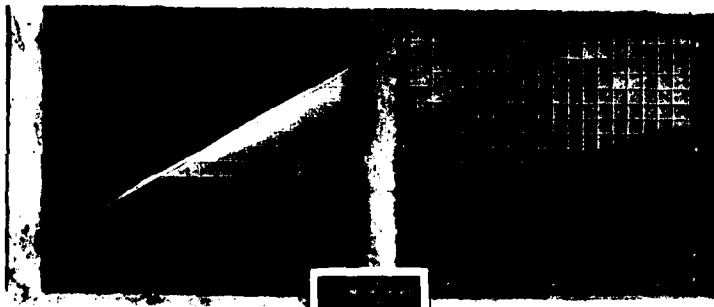
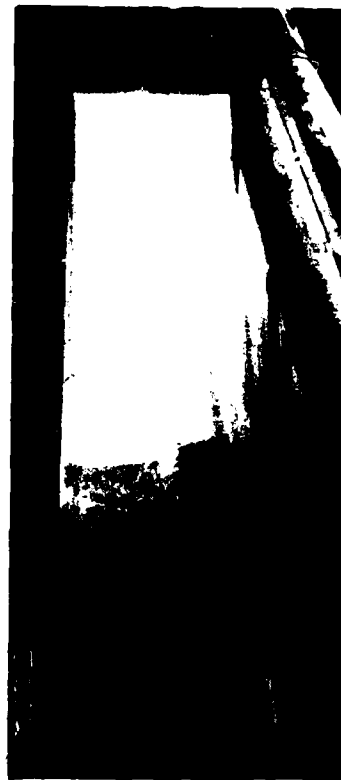
Figure 45. Plan 1, at start of the 1.0-ft static differential head test

30. Plan 1 was rebuilt and Figure 45 shows the streambank at the start of the 1.0-ft-static differential head test. The damage to the slope became progressively worse as the test proceeded and had not stabilized when the test was stopped after 461 hr (about 19 days). Figure 46 shows conditions at the end of the test; Figure 47 shows the condition of the streambank slope at intervals throughout the test.

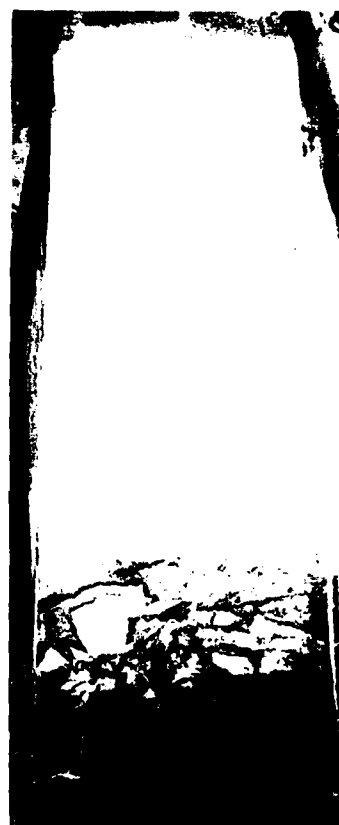
Figure 46. Plan 1, after the 1.0-ft static differential head test
